**Flood Control Project Maintenance  
Levee Inspections**

## Maintenance Issue Types Only, Levee Inspection Report By Mile - Spring 2018

### Sacramento Maintenance Yard West Levee Yolo Bypass

Waterway	Bank	Unit Miles	Inspection Start/End	Inspector
Unit No. 01 West Levee	Right	2.73	03/14/2018 03/14/2018	Zach Jojola

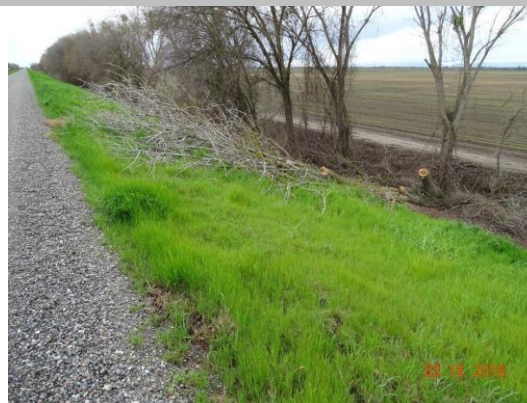
Photo 1 of 1 : SP\_2018\_ST0011\_291\_17\_20180315\_00016.jpg

LM Start	1.27	Rating **	M	Issue No.	17
LM End	1.27	Issue Type +	Ma	Location *	LS
Category	Earthen Levee			GPS Latitude/Longitude	
				Start	End
Item	Encroachments			38.743079 °	38.743079 °
				-121.660257 °	-121.660257 °
DWR ID	DWR_ST0011_01_s_2018_17				
Comment Code					
TR : Tree or limb					
Inspector Comment					
Cut tree branches and limbs on the landside slope.

View of cut tree on landside slope. Spring 2018.

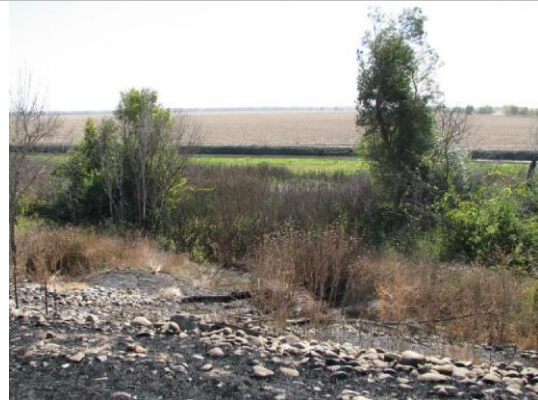
Photo 1 of 3 : UCIP\_SP\_2018\_52501\_60304.jpg

Comment Code					
Inspector Comment					
FS_ID:52501 DS_ID:17742 EP_NO: 10284 Repair Type: No Action Needed Crossing Status: Found UCIP Comments: Screw gates where removed and pipe was abanded by farmer, How pipe was abanded is unknown. FIELD_STRUCT_DESC: 1 of 2: 42-inch corrugated metal gravity drainage pipe through the levee, 23.6 feet below the crown. Slide gate on the waterside (WS) slope. Concrete distribution box at the landside (LS) toe. (42-inch pipe [HLM 2.63] authorized under Automatic Board Order (ABO) issued as Permit No. 10284, 1974 - La Borde and Hoover). [Additional Reference(s): DWR Levee Log, 2004. USACE Sacramento O&M Manual 127, June 1953, (Station 133+82)]. FS Date: 11/16/2017 1:59:55 PM

Waterside view: overview (pipe not found)

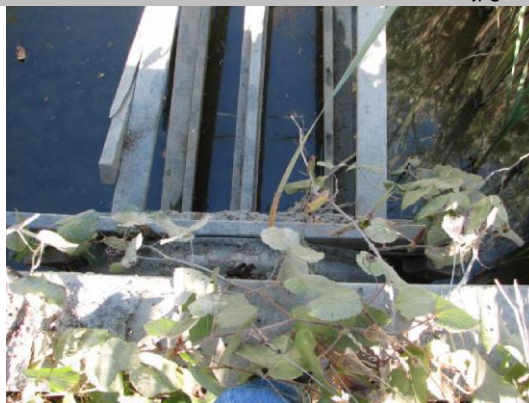
Photo 2 of 3 : UCIP\_SP\_2018\_52501\_60303.jpg

FS\_ID:52501  
DS\_ID:17742  
EP\_NO: 10284  
Repair Type: No Action Needed  
Crossing Status: Found  
UCIP Comments: Screw gates were removed and pipe was abandoned by farmer, How pipe was abandoned is unknown.  
FIELD\_STRUCT\_DESC: 1 of 2: 42-inch corrugated metal gravity drainage pipe through the levee, 23.6 feet below the crown. Slide gate on the waterside (WS) slope. Concrete distribution box at the landside (LS) toe. (42-inch pipe [HLM 2.63] authorized under Automatic Board Order (ABO) issued as Permit No. 10284, 1974 - La Borda and Hoover). [Additional Reference(s): DWR Levee Log, 2004. USACE Sacramento O&M Manual 127, June 1953, (Station 133+82)].  
FS Date: 11/16/2017 1:59:55 PM

Landside view: concrete spillbox/headwall and pipe (top view)

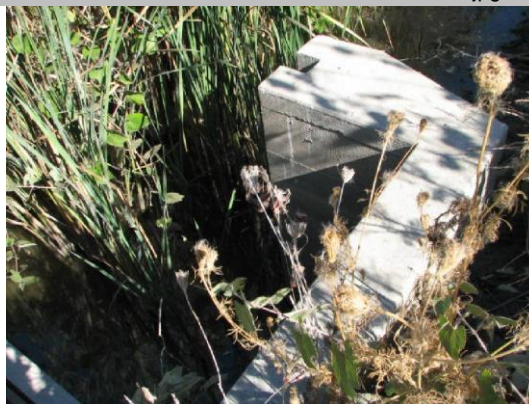
Photo 3 of 3 : UCIP\_SP\_2018\_52501\_60302.jpg

Landside view: side of concrete spillbox/headwall

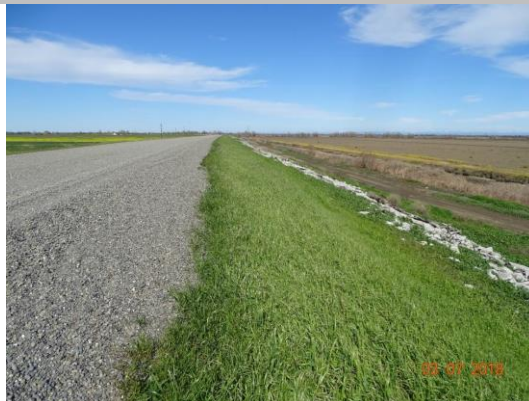
Photo 1 of 1 : SP\_2018\_ST0011\_292\_6\_20180308\_00012.jpg

LM Start	0.00	Rating **	M	Issue No.	6
LM End	1.51	Issue Type +	Ma	Location *	WS
Category	Earthen Levee			GPS Latitude/Longitude	
				Start	End
Item	Vegetation			38.718993 °	38.698737 °
				-121.664099 °	-121.674146 °
DWR ID	DWR_ST0011_02_s_2018_6				
Comment Code					
V1 : Control annual grass and weeds on the levee slopes and easements.					
Inspector Comment

View of vegetation on the waterside slope. Spring 2018.

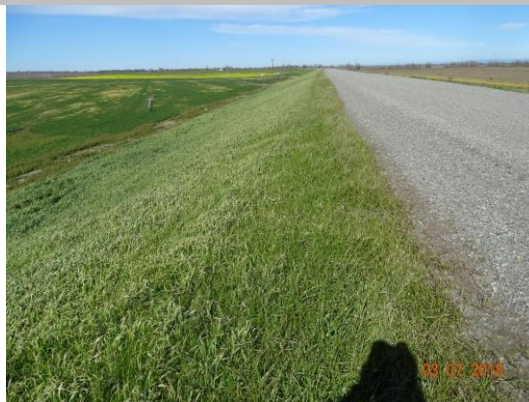
Photo 1 of 1 : SP\_2018\_ST0011\_292\_4\_20180308\_00013.jpg

LM Start	0.00	Rating **	M	Issue No.	4
LM End	1.51	Issue Type +	Ma	Location *	LS
Category	Earthen Levee			GPS Latitude/Longitude	
				Start	End
Item	Vegetation			38.718993 °	38.698736 °
				-121.664099 °	-121.674146 °
DWR ID	DWR_ST0011_02_s_2018_4				
Comment Code					
V1 : Control annual grass and weeds on the levee slopes and easements.					
Inspector Comment

View of vegetation on the landside slope. Spring 2018.

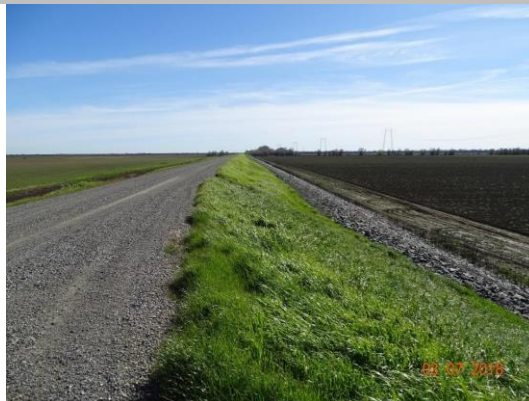
Photo 1 of 1 : SP\_2018\_ST0011\_293\_4\_20180308\_00011.jpg

LM Start	0.00	Rating **	M	Issue No.	4
LM End	1.48	Issue Type +	Ma	Location *	LS
Category	Earthen Levee			GPS Latitude/Longitude	
				Start	End
Item	Vegetation			38.698541 °	38.677231 °
				-121.674119 °	-121.672803 °
DWR ID	DWR_ST0011_03_s_2018_4				
Comment Code					
V1 : Control annual grass and weeds on the levee slopes and easements.					
Inspector Comment

View of vegetation on the landside slope. Spring 2018.

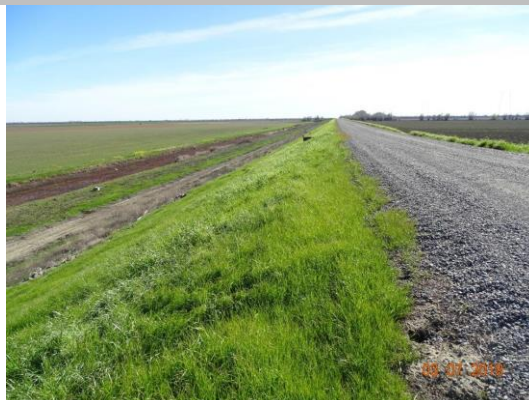
Photo 1 of 1 : SP\_2018\_ST0011\_293\_5\_20180308\_00010.jpg

LM Start	0.00	Rating **	M	Issue No.	5
LM End	1.48	Issue Type +	Ma	Location *	WS
Category	Earthen Levee			GPS Latitude/Longitude	
				Start	End
Item	Vegetation			38.698541 °	38.677231 °
				-121.674118 °	-121.672803 °
DWR ID	DWR_ST0011_03_s_2018_5				
Comment Code					
V1 : Control annual grass and weeds on the levee slopes and easements.					
Inspector Comment

View of vegetation on the waterside slope. Spring 2018.

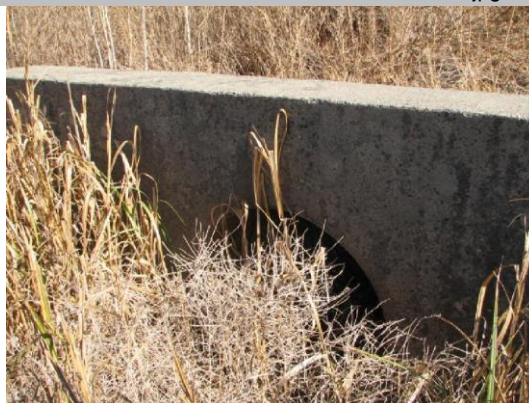
Photo 1 of 3 : UCIP\_SP\_2018\_44826\_60517.jpg

LM Start	0.60	Rating **	A/W	Issue No.	28	
LM End	0.60	Issue Type +	Ma	Location *		
Category	Supplemental			GPS Latitude/Longitude		
				Start		End
Item	DWR UCIP LMA Responsibility			38.565704 °		38.565704 °
				-121.638650 °		-121.638650 °
DWR ID						
Comment Code						
Inspector Comment						
FS_ID:44826 DS_ID:528 EP_NO: 10304 Repair Type: No Action Needed Crossing Status: Found UCIP Comments: FIELD_STRUCT_DESC: 30-inch corrugated metal gravity drainage pipe through the levee, 22 feet below the crown. Flap gate on the waterside (WS) end. (30-inch pipe [HLM 0.59] authorized under Automatic Board Order (ABO) issued as Permit No. 10304, 1974 - Southern Pacific Transportation Company). [Additional Reference(s): DWR Levee Log, 2004. USACE Sacramento O&M Manual 120, June 1952, (Station 446+08)]. FS Date: 4/28/2015 2:58:55 PM

Landside view: concrete headwall.

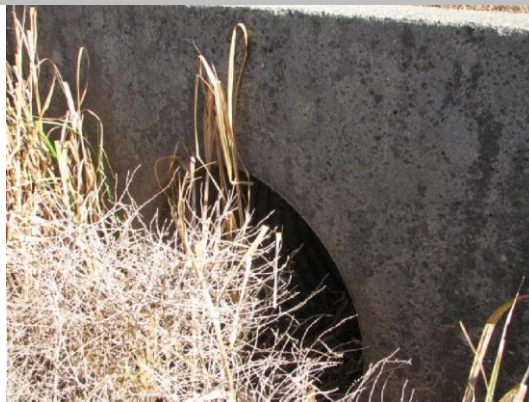
Photo 2 of 3 : UCIP\_SP\_2018\_44826\_60516.jpg

Landside view: closer look at the headwall.

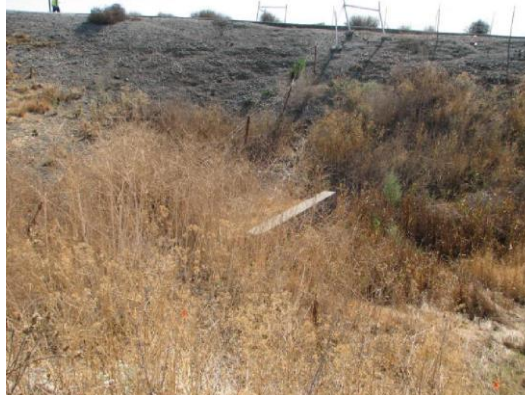
Photo 3 of 3 : UCIP\_SP\_2018\_44826\_60520.jpg

LM Start	0.60	Rating **	A/W	Issue No.	28 (cont)	
LM End	0.60	Issue Type +	Ma	Location *		
Category	Supplemental			GPS Latitude/Longitude		
				Start		End
Item	DWR UCIP LMA Responsibility			38.565704 °		38.565704 °
				-121.638650 °		-121.638650 °
DWR ID						
Comment Code						
Inspector Comment						
FS_ID:44826 DS_ID:528 EP_NO: 10304 Repair Type: No Action Needed Crossing Status: Found UCIP Comments: FIELD_STRUCT_DESC: 30-inch corrugated metal gravity drainage pipe through the levee, 22 feet below the crown. Flap gate on the waterside (WS) end. (30-inch pipe [HLM 0.59] authorized under Automatic Board Order (ABO) issued as Permit No. 10304, 1974 - Southern Pacific Transportation Company). [Additional Reference(s): DWR Levee Log, 2004. USACE Sacramento O&M Manual 120, June 1952, (Station 446+08)]. FS Date: 4/28/2015 2:58:55 PM

Landside view: overview

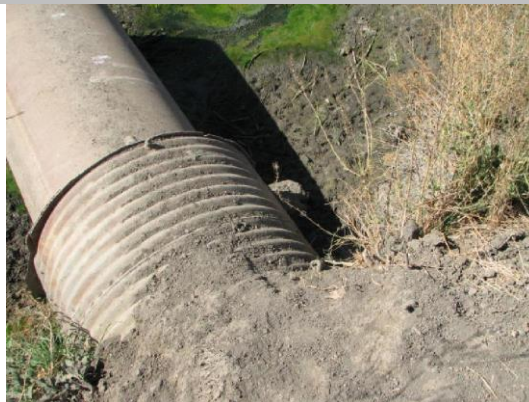
Photo 3 of 3 : UCIP\_SP\_2018\_44822\_24978.jpg

FS\_ID:44822  
DS\_ID:17736  
EP\_NO: 10306  
Repair Type: No Action Needed  
Crossing Status: Found  
UCIP Comments: Farmer cleans this screw gate every year  
FIELD\_STRUCT\_DESC: 48-inch corrugated metal gravity drainage pipe through the levee, 21.5 feet below the crown. 42-inch steel pipe inside the 48-inch pipe. Flap gate on the waterside (WS) with two cutoff walls, one headwall, and one saddle and apron. (48-inch pipe [HLM 2.12] authorized under Automatic Board Order (ABO) issued as Permit No. 10306, 1974 - Wells Fargo Bank, Trustees for Cowell Foundation).  
[Additional Reference(s): USACE Sacramento O&M Manual 119, December 1952, (Station 80+00)].  
FS Date: 4/28/2015 2:57:49 PM

Landside view: closer look at 42-inch steel pipe and 48-inch CMP

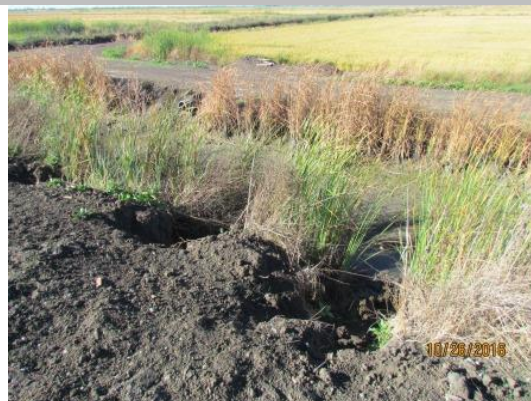
Photo 2 of 2 : SP\_2018\_ST0011\_294\_19\_20180306\_00016.jpg

LM Start	2.11	Rating **	A/W	Issue No.	19
LM End	2.11	Issue Type +	Ma	Location *	LS
Category	Earthen Levee			GPS Latitude/Longitude	
				Start	End
Item	Erosion / Bank Caving			38.545430 °	38.545430 °
				-121.631211 °	-121.631211 °
DWR ID	DWR_ST0011_04_f_2016_19				
Comment Code					
E1 : Note and monitor erosion site.					
Inspector Comment					
It appears that the ditch is beginning to erode the landside levee toe, but is not within the levee prism. Recommend monitoring.

Closer view of erosion. Fall 2016.

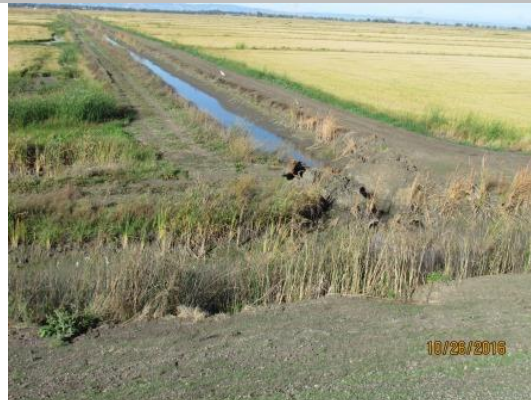
Photo 1 of 2 : SP\_2018\_ST0011\_294\_17\_20180306\_00010.jpg

LM Start	2.14	Rating **	A/W	Issue No.	17
LM End	2.14	Issue Type +	Ma	Location *	LS
Category	Earthen Levee			GPS Latitude/Longitude	
				Start	End
Item	Erosion / Bank Caving			38.545022 °	38.545022 °
				-121.631209 °	-121.631209 °
DWR ID	DWR_ST0011_04_f_2016_17				
Comment Code					
E1 : Note and monitor erosion site.					
Inspector Comment					
It appears that the ditch is beginning to erode the landside levee toe, but is not within the levee prism. Recommend monitoring.

View of erosion at landside levee toe. Fall 2016.

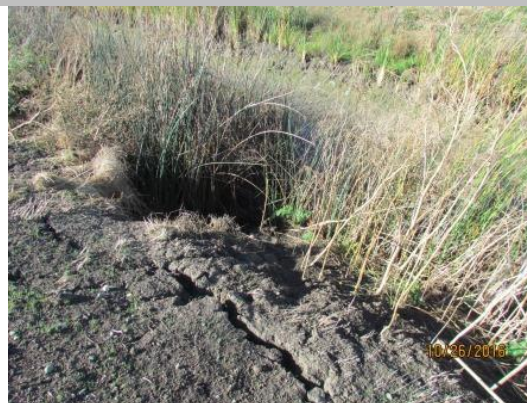
Photo 2 of 2 : SP\_2018\_ST0011\_294\_17\_20180306\_00011.jpg

LM Start	2.14	Rating **	A/W	Issue No.	17 (cont)	
LM End	2.14	Issue Type +	Ma	Location *	LS	
Category	Earthen Levee			GPS Latitude/Longitude		
				Start		End
Item	Erosion / Bank Caving			38.545022 °		38.545022 °
				-121.631209 °		-121.631209 °
DWR ID	DWR_ST0011_04_f_2016_17					
Comment Code						
E1 : Note and monitor erosion site.						
Inspector Comment						
It appears that the ditch is beginning to erode the landside levee toe, but is not within the levee prism. Recommend monitoring.

Closer view of erosion. Fall 2016.
